***FINAL***  
***Historic Structures Management Plan***  
***Sault Ste. Marie, Michigan***

*18 November 1998*

Gray & Pape, Inc.  
1318 Main Street  
Cincinnati, Ohio 45210

**HISTORIC STRUCTURES MANAGEMENT PLAN  
SAULT STE. MARIE, MICHIGAN**

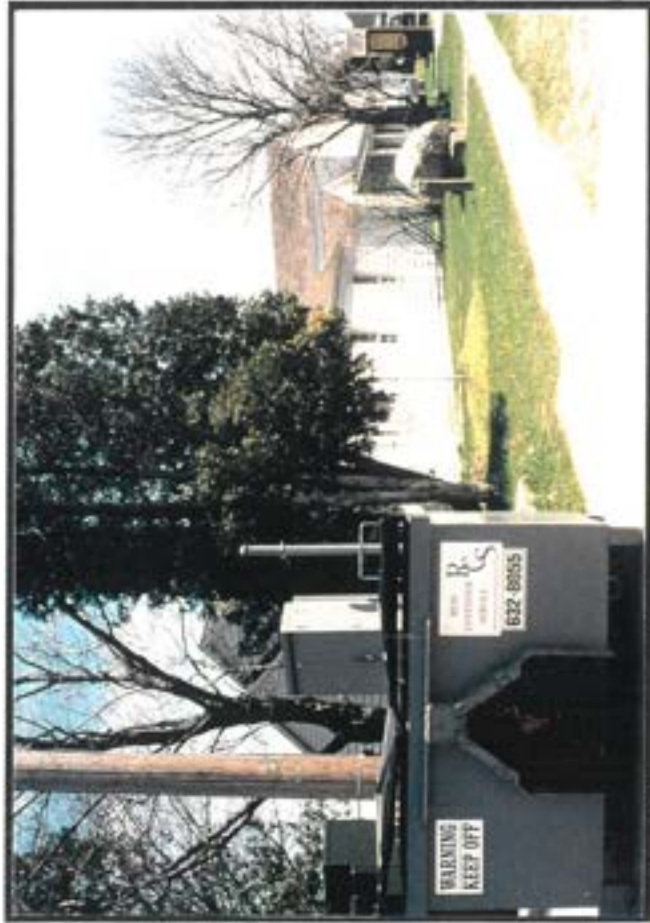
Plate 13. View northeast of project area from Coast Guard facility showing disruption of the view (and passage along the street) due to dumpster location in the sidewalk.

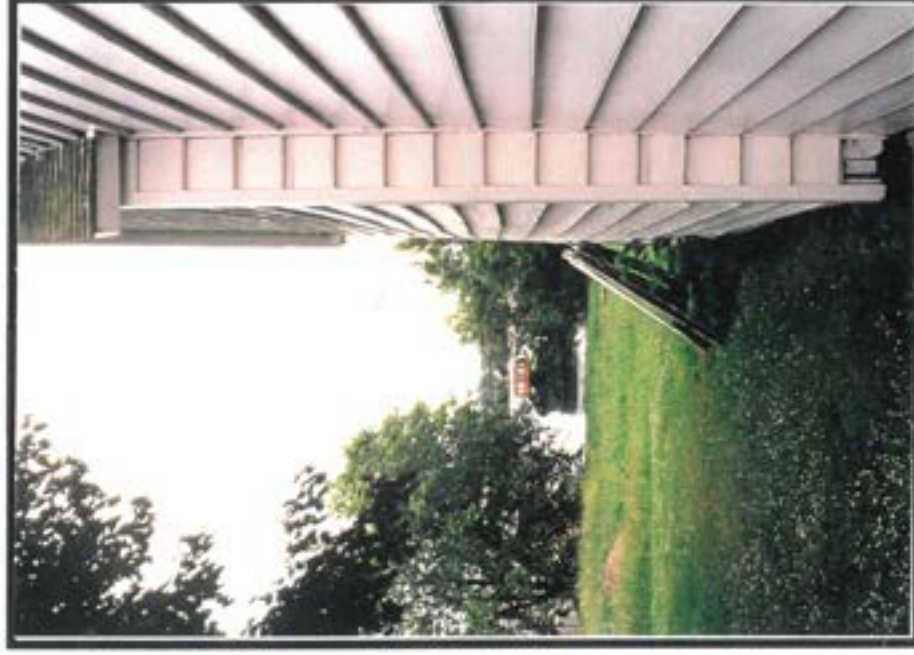
Plate 18. View north of west side of Johnston House, showing the bowed wall where original portion of house was taken off.

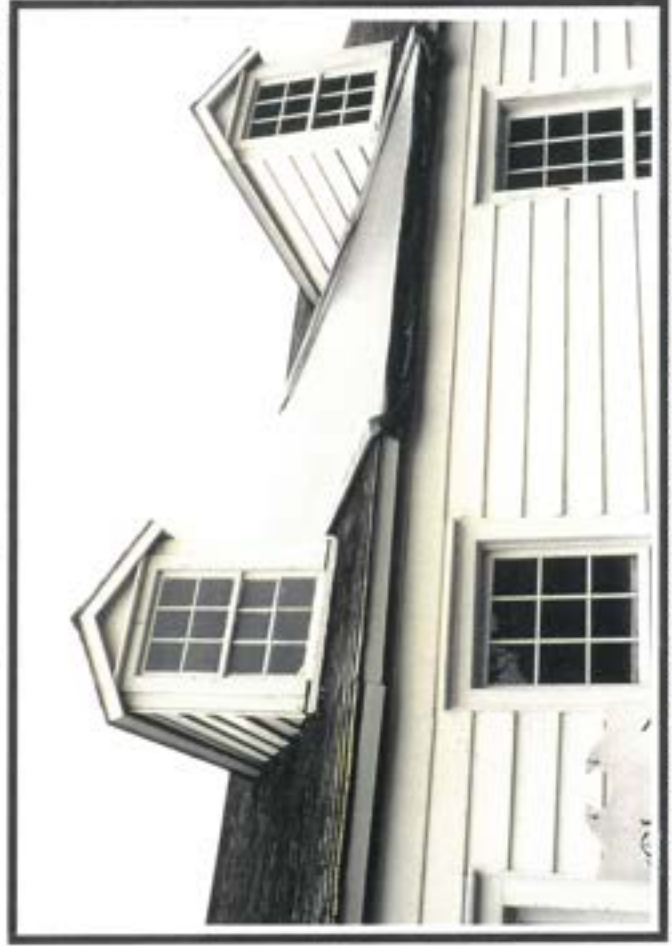
Plate 22. View northeast of south roof slope of Johnston House, showing the temporary tarp installed to prevent water leakage.

Observations inside the attic were very difficult for the south sloping roof; however, from outside there is evidence of the same connection deterioration. Paneling around the south roof dormers suffers extensive microbiotic deterioration from continuous leakage problems. Roof structural changes from deteriorated connections at the rafter plate beam have allowed gaps at the base of dormer assemblies which have contributed to leakage (Plate 22). Rafters are overlain by well-spaced sawn sheathing boards and covered with wood shingles. Flashing at dormers and roof offsets are poorly installed, badly deteriorated, or missing completely.

- Multiple deteriorations of roof structural connections and components are contributing to increased leakage.
- Deteriorated, lost, or poorly installed roof covering elements (flashing) are causing leakage.
- There are accelerated decay problems throughout the structure. The roof system needs replacement.

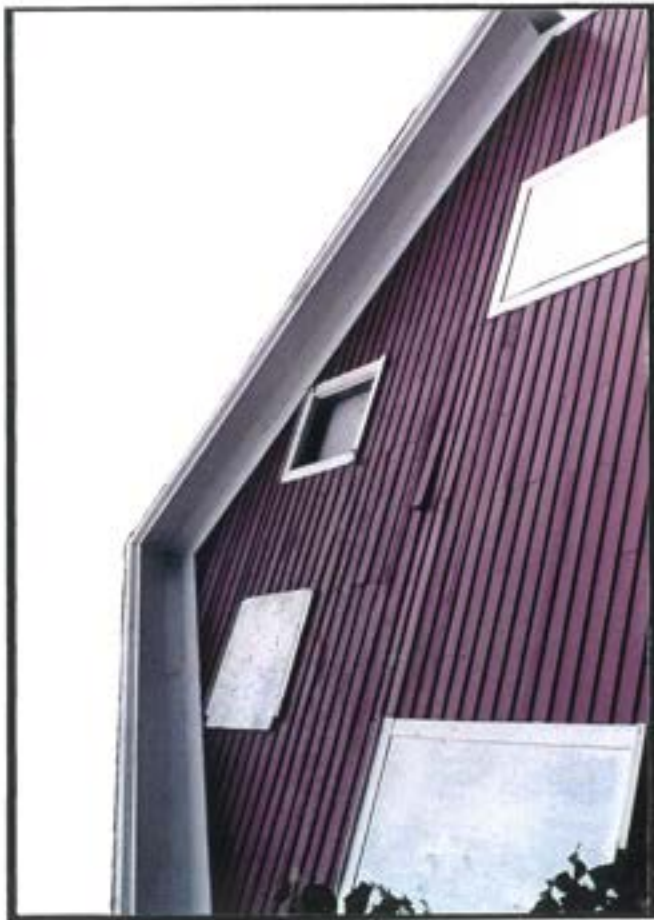
Plate 27. View of clapboard damage on east wall of Baraga House, facing west (and up).

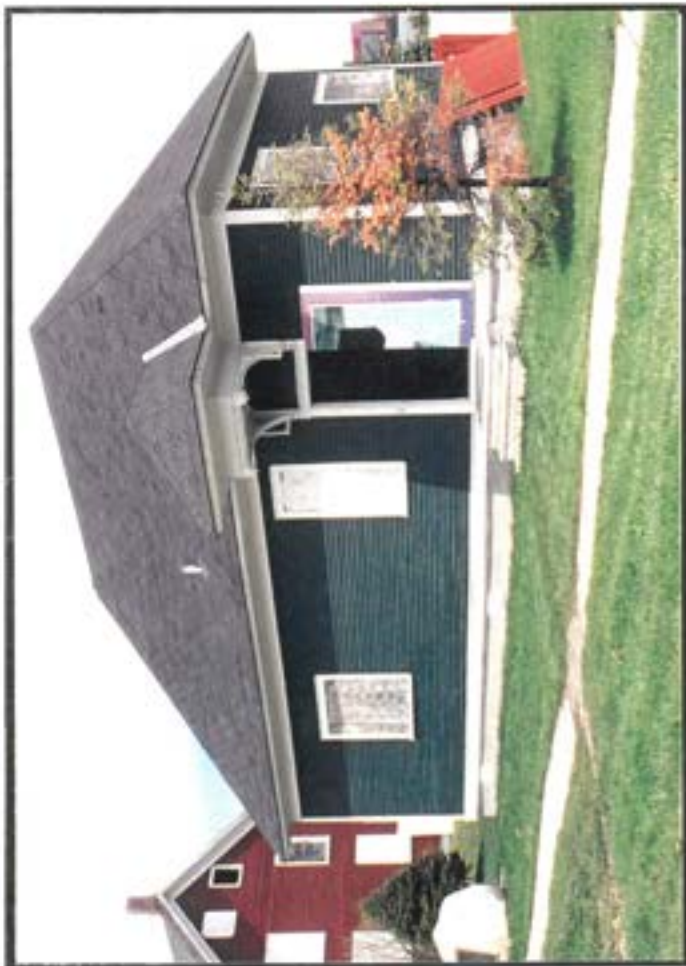
- The crawl space is very damp, foundation vents have been covered with steel protection plates which impede air circulation (Plates 33 and 34).

Plate 33. Kemp Coal Dock Office, view of south and east sides of building from Water Street, facing northwest.

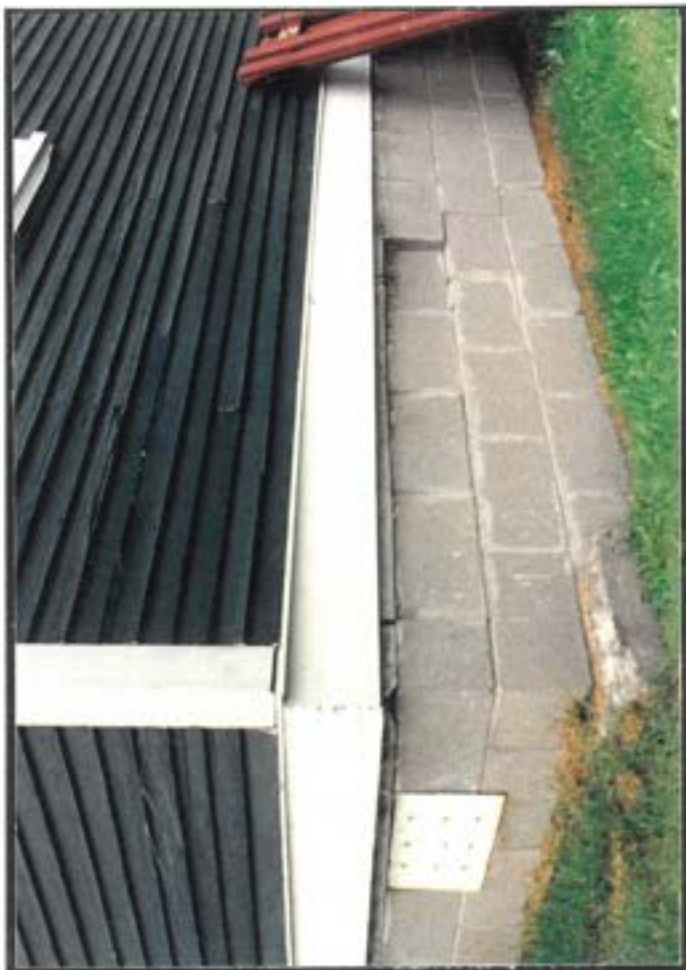
Plate 34. View of skewed line in concrete block wall at the southeast corner of the Kemp Coal Dock office building, facing northwest.

- High level of ground moisture beneath and surrounding the building at the time of inspection.
- Damage along the east foundation wall near the southeast corner. CMU are pushed inward for a distance of about 6' (Plate 34).
- Depth of footings unknown.

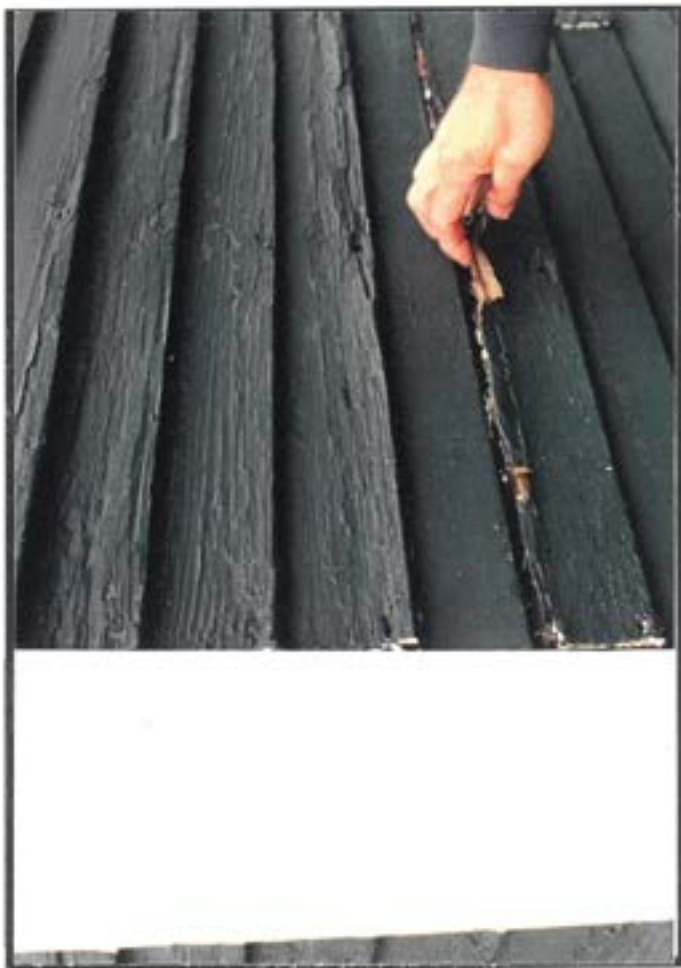
Plate 35. View of rot in clapboards on east wall of Kemp Coal Dock Office building, facing northwest.
