***FINAL***  
***Historic Structures Management Plan***  
***Sault Ste. Marie, Michigan***

*18 November 1998*

Gray & Pape, Inc.  
1318 Main Street  
Cincinnati, Ohio 45210

**HISTORIC STRUCTURES MANAGEMENT PLAN  
SAULT STE. MARIE, MICHIGAN**

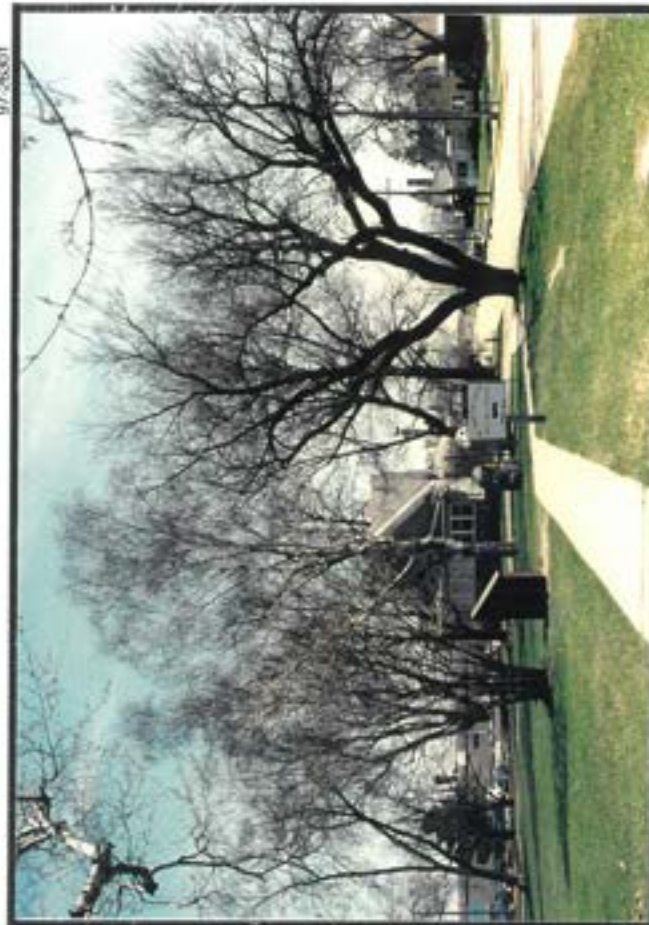
Plate 10. View of Brady Park from the east end in the spring without tree foliage, facing east.

residential neighborhood (Plate 10). Glimpses of the bow of the Valley Camp and perhaps the bright yellow entrance sign to the Soo Locks Boat Tour #2 are the only apparent clues of tourist attractions from this vantage point, and those can only be obtained during the months when the least number of tourists are around.

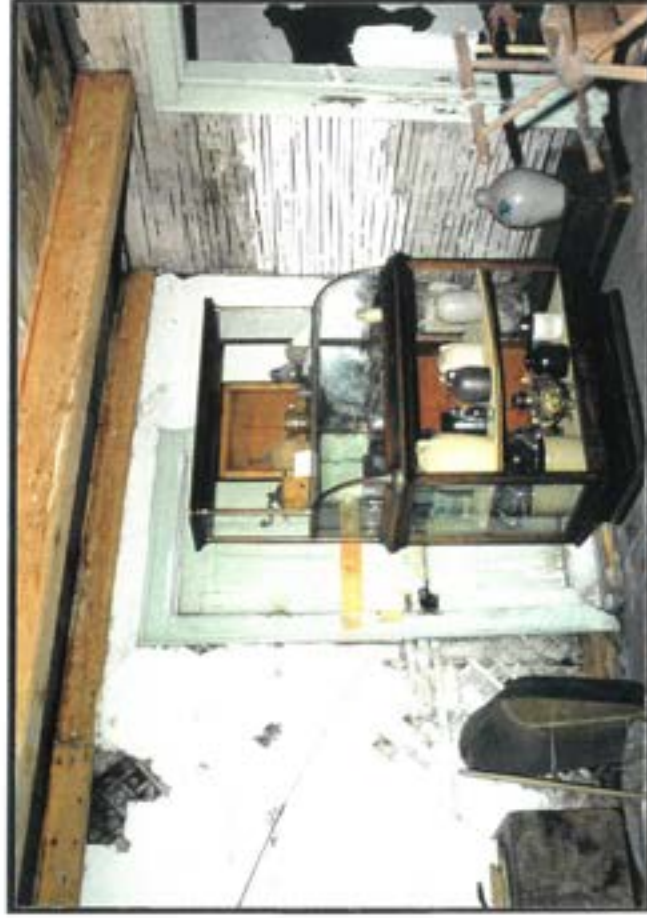
Plate 19. Interior view of Johnston House, showing both cross lath and split lath.

Other walls within the building are constructed of two distinct types representing different periods of construction. The older partitions are constructed of hand-sawn boards of 1-1/2" thickness laid vertically in panels. The panels are then covered by hand split lath that is attached in an overlapping diamond or woven pattern and plastered with a single layer of lime rich horsehair plaster (Plates 19 and 21).

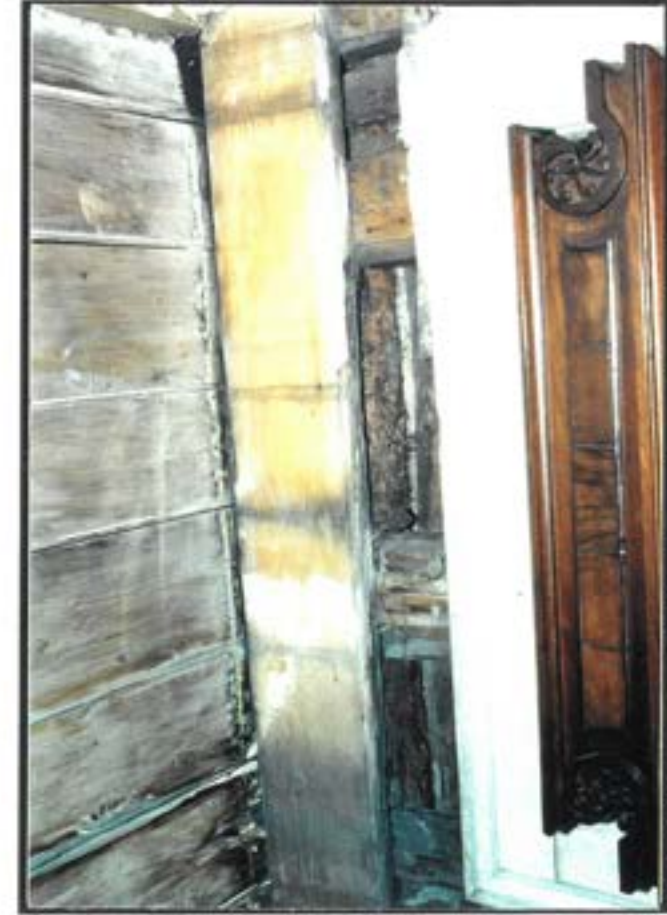
The building is constructed of hewn post and beam bays set 5' apart with vertical posts grooved to receive hewn log sections laid horizontally between posts. One section of older wall at the west end reveals smaller round log infill (Plate 20). These older logs were installed without removing the natural bark covering. This infill of chinked logs extends full height to the rafter plate beam. Individual bay frame elements are tied together by their connection to continuous sill and rafter plate beams, all joined by pegged mortise and tenon method. East and west end walls are provided with vertical posts at approximately 10' oc with similar log infill construction.

Plate 20. Interior view of Johnston House, showing the round cedar log construction on the west wall where the original house and addition are connected, facing west and up.

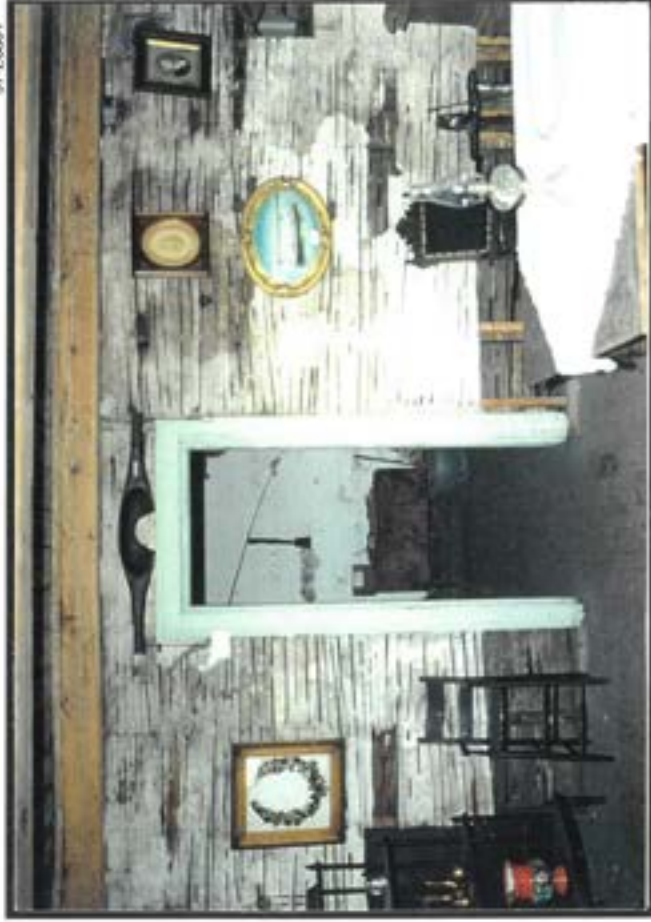
Later walls were constructed of 2" x 5" studs spaced at 18" oc covered with hand split lath in a parallel horizontal pattern and plaster with one or more layers of lime rich plaster (Plate 21). The second floor (attic) walls are probably of the most recent construction. These are constructed of 2" x 5" studs at 18" oc covered with 3/4" T & G paneling.

Plate 21. Interior view of Johnston House, showing the middle room and the split lath exposed on the east wall, facing east.

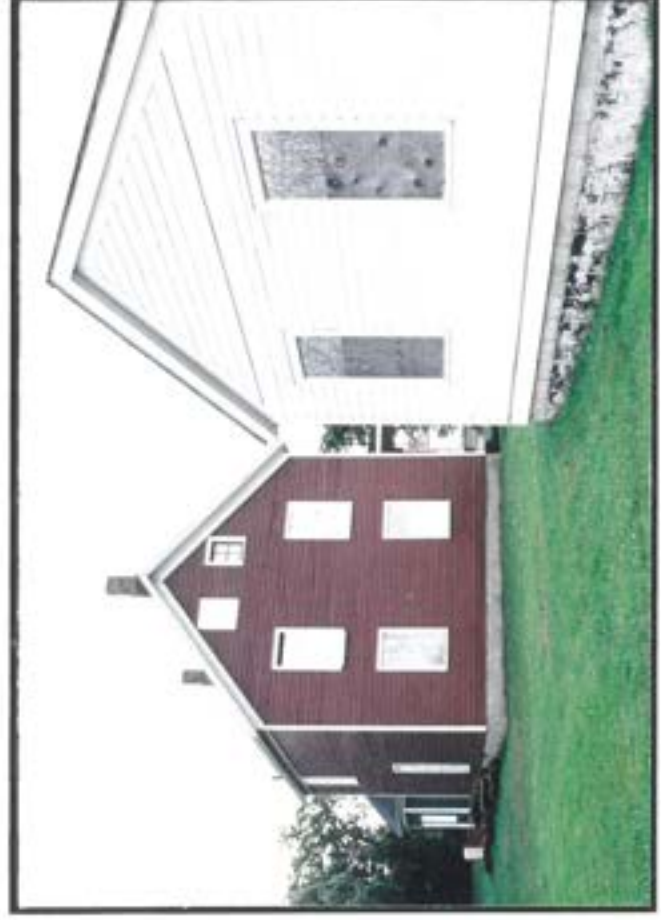
Plate 26. View of west and north sides of Baraga House and its relationship to the Schoolcraft House east dependency, facing southeast.

final decision on future use, immediate stabilization needs to address, in prioritized order, repair of roof flashing and trim on the main structure, improving window protection at miscellaneous locations, reattachment of random siding pieces, and completion of foundation pointing (Plates 26 and 27).

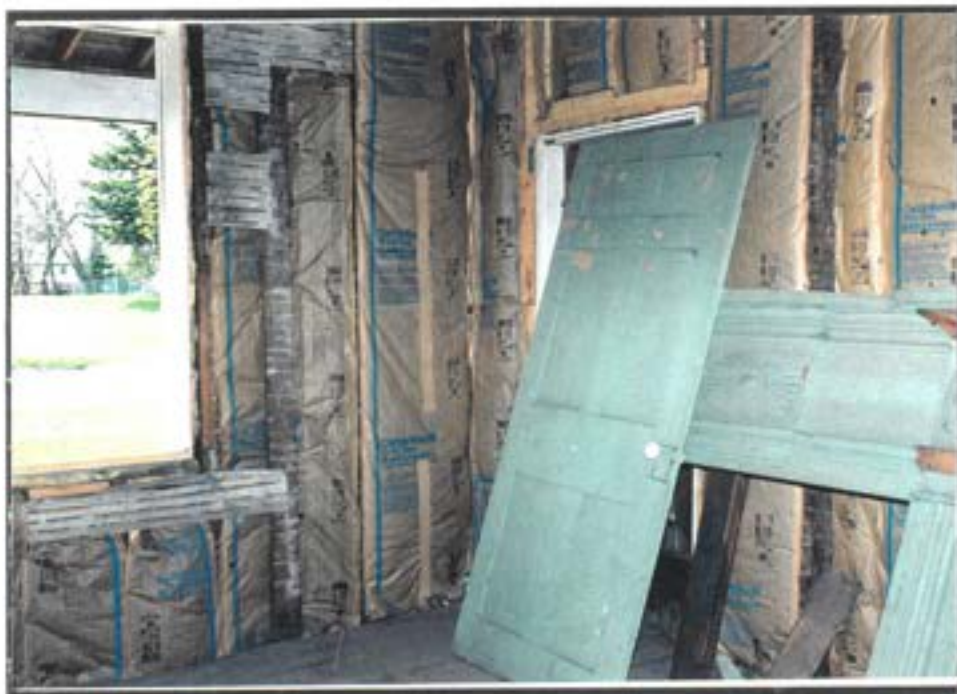
All interior openings are trimmed, however, window openings are not. Much miscellaneous trim is on site (Plate 31). The baseboard is about 50 percent intact throughout. Three of the mantels

Plate 31. View of first floor interior in rear parlor, Schoolcraft House, facing south.

are assembled and on site with pieces of a fourth also in the building (Plate 31). Interior door casings are of two predominant and similar styles. One style is attached with wire nails while the other with square nails. Picture molding is present in various locations throughout the house.

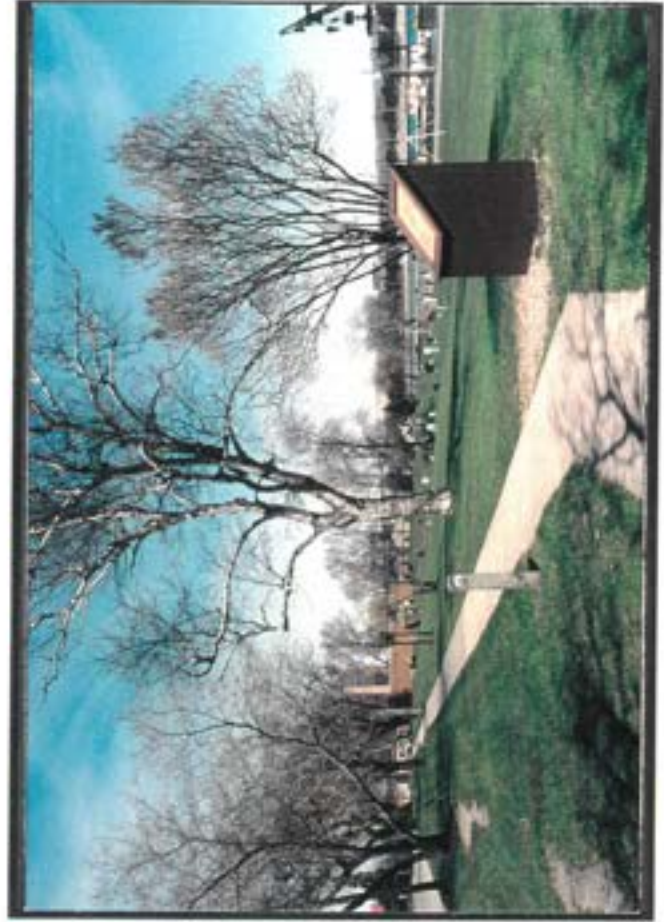
The present signage in the Water Street Museums area matches the exhibit panels seen along the Water Street corridor in Soo Locks Park and Brady Park (Plate 43). Located between the Johnston and the Schoolcraft houses, these panels are accompanied by state historical markers which refer to these two buildings (Plate 44). Small wood markers emblazoned with the city's logo of a ship, another 1980s streetscape element along the entire corridor, are in very poor condition.

These older exhibit panels and wood markers are worn and appear outdated in design. The state historical markers should stay in place, but the rest of the present signage needs to be replaced

Plate 43. View of Brady Park signage and exhibit podium, facing northwest.

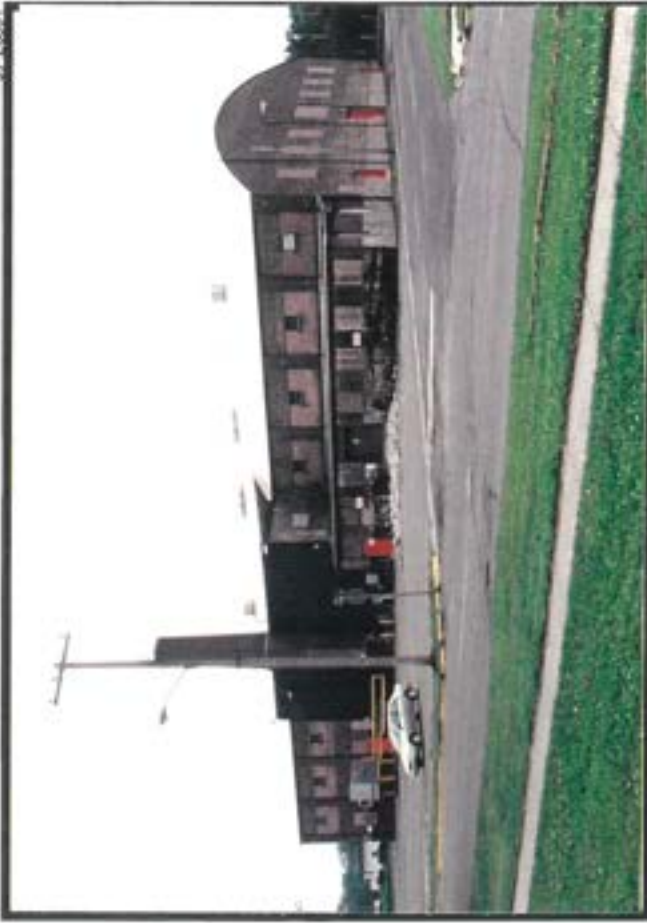
Plate 45. View of north side (rear) of Pullar Community Center from Water Street, facing southeast.

Existing parking areas in the immediate vicinity are essential resources. Across Water Street to the south is the paved lot at the rear of the Pullar Community Center (Plate 45). Landscaping, an effort to beautify the center's rear elevation facing the museum buildings, and well-defined circulation patterns in this lot can improve its use for both the community center and the museum buildings. At the northeast corner of this lot is a small brick pump house which must remain. Proper landscaping screening will enable it to visually harmonize with the adjacent historic properties.

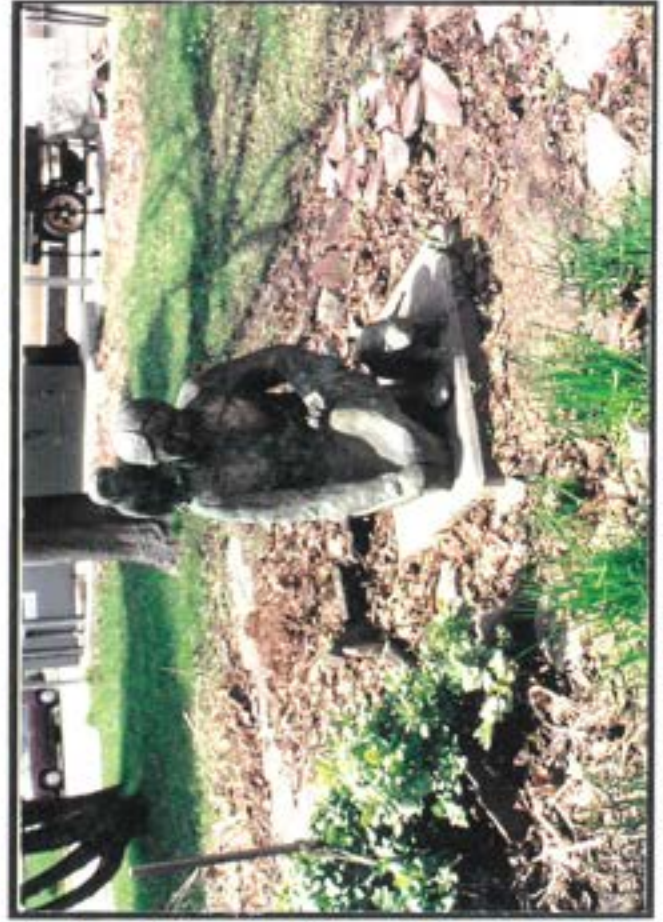
Plate 46. Close-up view of statue of O-Zhaw-Guscoday-Way-Oua (Mrs. Johnston) in Johnston House garden, facing southwest.

The small garden and statue west of the Johnston House is also suggested for relocation into the north garden area proposed for the Johnston House. The driveway relocation discussed previously would provide the motivation for this move. Whether relocated or not, a larger planting bed is proposed to surround the statue of Mrs. Johnston (Plate 46). Plantings in the garden could replicate those known to have existed in Mrs. Johnston's garden and those of her descendants. The north area behind the Johnston House should be set apart through the planting of trees both to screen the U.S. Coast Guard building on the west and the towing operation to the north. The tree screen could encircle the north yard and form a small entrance between the Johnston and Schoolcraft houses.

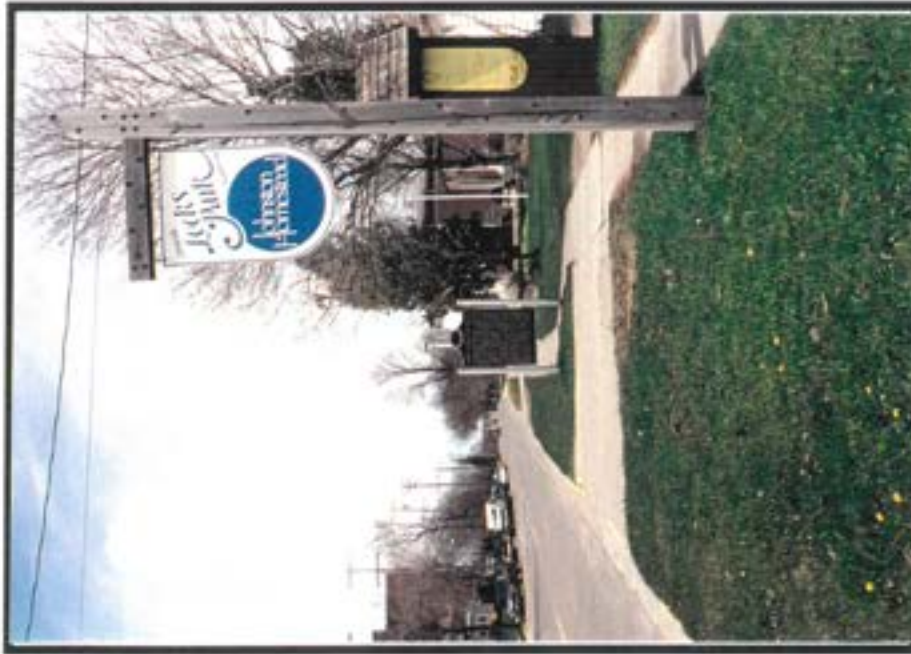
Plate 44. West view from in front of Schoolcraft House, showing varied types of signage in project area.

with text panels or other interpretive displays, such as sculpture, that is more colorful and simple in its design. The name of each building should be clearly marked by signs on both their north and south sides. Directional signage should be installed at the marina entrance and the east and west ends of the museums area to guide visitors to major destinations including the River of History Museum, central business district, Valley Camp and Ships' Store, and Soo Locks.
